# Longitudinal Section Inspection and Quality Assessment of Grouting Sleeves in Precast Bridge Piers

**Abstract:** This study investigates the construction quality and potential defects of grouted sleeve connections in a prefabricated bridge pier dismantled from a project in Shanghai using section-cutting inspection. Ten samples were examined with a focus on grout compactness, reinforcement anchorage length, and centering accuracy. The results show that the grout within the sleeves was highly compact, and all mechanical performance indices satisfied the relevant specifications and design requirements, indicating overall reliable construction quality. Minor deficiencies, including slightly insufficient anchorage length and deviations in reinforcement centering, were identified but are considered to have negligible effects on load-bearing and deformation capacities on the basis of existing research. The findings suggest that the current construction process generally meets quality requirements; however, improvements in grout mix proportion, construction procedures, and the addition of external threading on the sleeve surface are recommended to enhance bonding with surrounding concre

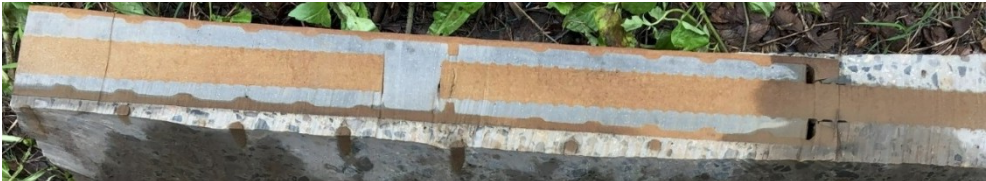
| No. | Photograph of samples |
|---|---|
| No.6 | |

| Sample Number | Construction Defects | | | |
|---|---|---|---|---|
| No.6 | 8 | 56 | 222 | 6 |

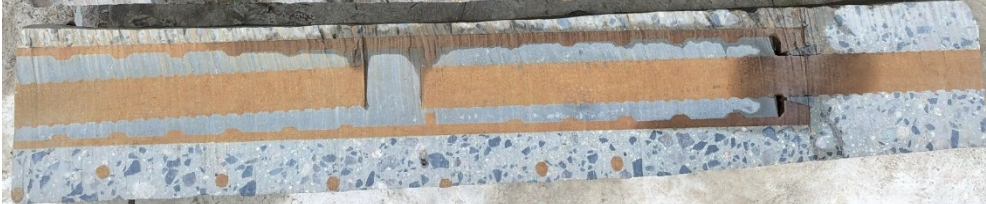
| No. | Photograph of samples |
|---|---|
| No.7 | |

| Sample Number | Construction Defects | | | |
|---|---|---|---|---|
| No.7 | 8 | 51 | 129 | 1 |

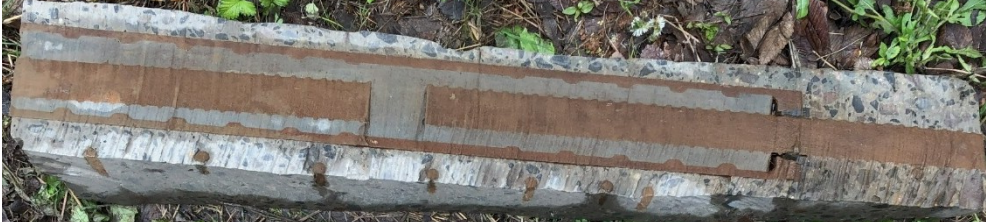
| No. | Photograph of samples |
|---|---|
| No.10 | |

| Sample Number | Construction Defects | | | |
|---|---|---|---|---|
| No.10 | 7 | 50 | 303 | 7 |

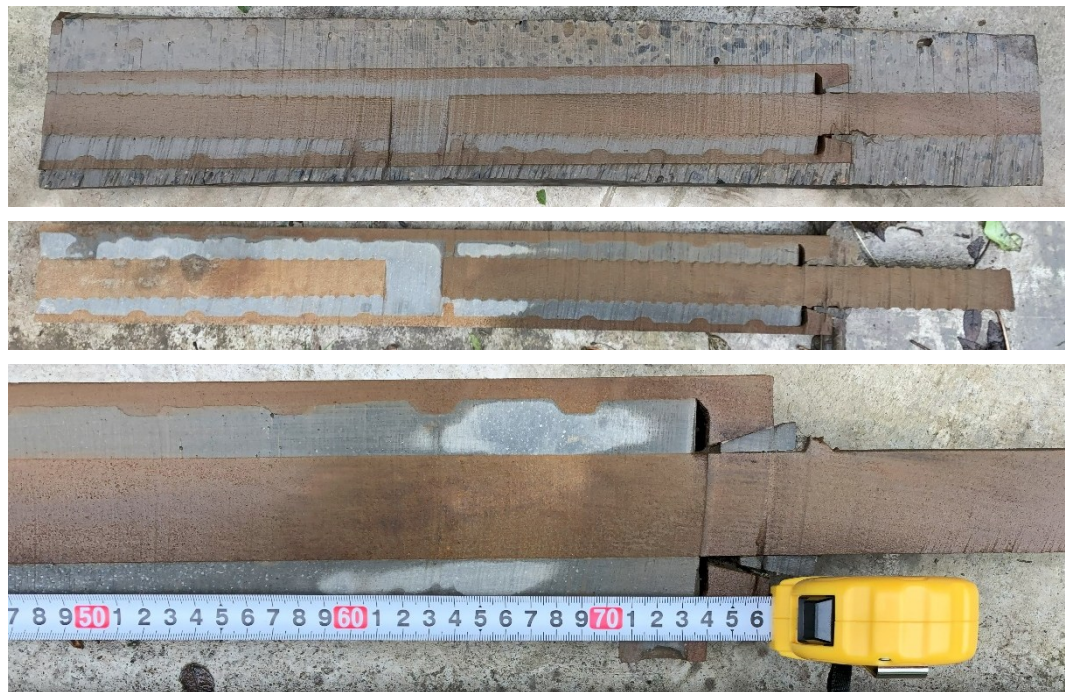
- (1) Defect manifestation (Figure 6): All ten samples exhibited voids ranging from 5 mm to 11 mm near the grout outlet at the top of the sleeve, resulting in slightly reduced rebar anchorage lengths. In addition, some rebars embedded in the pile cap were 26 mm to 60 mm shorter than the design requirements, with anchorage lengths approximately 1d shorter than the designed length (10d).

- (2) Cause analysis: The voids at the top of the sleeve are attributed primarily to grout settlement or shrinkage after grouting completion. The insufficient anchorage length of the pile cap reinforcement may result from inaccuracies in rebar fabrication or embedding, as well as positioning deviations and deformations during construction.

- (3) Safety implications: According to a study by Li et al. [5], when the grout defect height does not exceed 30% of the rebar anchorage length, the joint performance can still meet the requirements. The void heights (5–11 mm) and anchorage length deficiencies (26–60 mm) observed in this study are relatively small compared with the rebar anchorage length of 400 mm (10d, where  $d = 40$  mm). Therefore, these defects have a negligible effect on the overall mechanical performance of the grouted sleeves. However, the voids at the top may adversely affect the durability of the reinforcement, although no corrosion or other durability issues were observed in the sectioned samples to date.

**Figure 6** Example of a sectioned grouted sleeve—void near the grout outlet causing slightly reduced reinforcement anchorage length

- (1) Construction management and process improvements
  - ① Enhance construction management training to improve construction accuracy. Employ high-precision modules to fix the positions of the reinforcement and sleeves, addressing issues such as insufficient anchorage length and rebar eccentricity; and
  - ② Improve the grouting process by installing check valves or double-bend pipes at the grout outlet to prevent backflow of the grout that causes voids at the top.
- (2) Grout material optimization
  - ① Optimize the grout mix proportion by using formulations with low shrinkage to reduce void formation caused by grout shrinkage; and
  - ② Strictly control the grout volume to ensure adequate grout compactness through the use of a sufficient quantity of material.
- (3) Sleeve structural optimization

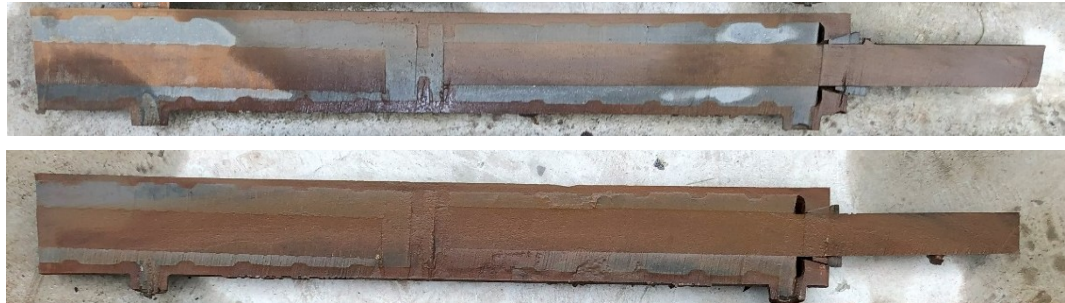
- (1) Defect manifestation (Figure 7): The embedded rebars in the pile cap exhibited certain eccentricities within the sleeves, with eccentricity lengths ranging from approximately 176 mm to 392 mm and lateral displacement of approximately 9 mm.
- (2) Cause analysis: Due to the large number of embedded rebars in the pile cap, deformation and positioning deviations during construction led to some rebars being eccentrically positioned within the sleeves during column installation.

- (3) Safety implications: According to studies by Su [6] and Feng [7], rebar eccentricity has a minor effect on the ultimate bearing capacity of joints but primarily affects deformation behavior. Therefore, the lateral displacement of 9 mm observed in this study can be considered negligible in terms of its impact on the load-bearing capacity of the components.

**Figure 7** Example of a sectioned grouted sleeve—offset of embedded reinforcement bars in the pile cap

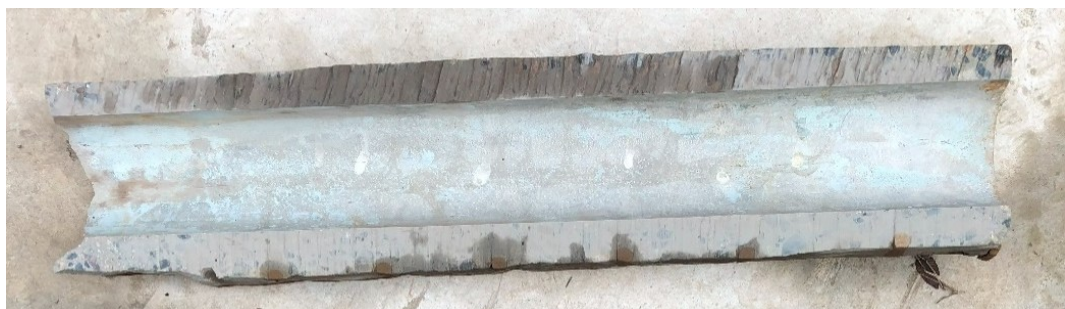
- (1) Defect manifestation (Figure 8): During the sectioning of the grouted sleeves, delamination was observed between the outer wall of the sleeve and the surrounding concrete, with the concrete surface appearing relatively smooth.
- (2) Cause analysis: This indicates insufficient bond strength between the sleeve outer wall and the concrete, resulting in a lack of effective mechanical interlocking.

**Figure 8** Example of a sectioned grouted sleeve—delamination between sleeve outer wall and concrete

The addition of threaded features to the outer surface of the grouted sleeve is recommended to increase bonding between the sleeve and the concrete, preventing delamination.
